Manhole Inspection Summary

Manhole # S05GG1011MH

Insp Date: **6/25/07 10:31 AM**

Location Address: **3826 FERNHILL AVE**

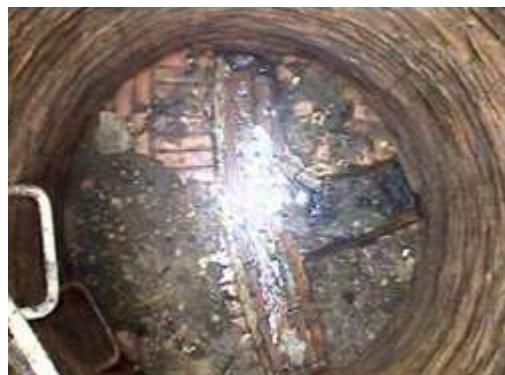
Top View

DEBRIS ON CHANNEL AND BENCH

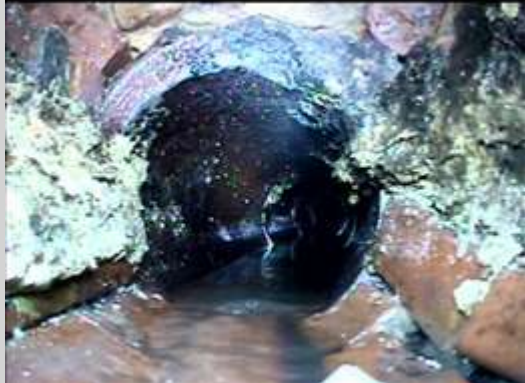
12 O'Clock Outflow

8 in. Circular Gravity Sewer
Pipe Out @ 12 O'Clock

Invert Depth: **10.10** (ft.) Flow Characteristics: **Slow**

Deposits: ☐ None ☐ Mud ☐ Sludge ☐ Debris ☒ **Grease**

Silt Depth: **2.5** (in.) Deposits Extent: **Medium**

Infiltration: **None** Pipe Seal Cond: **Unknown**

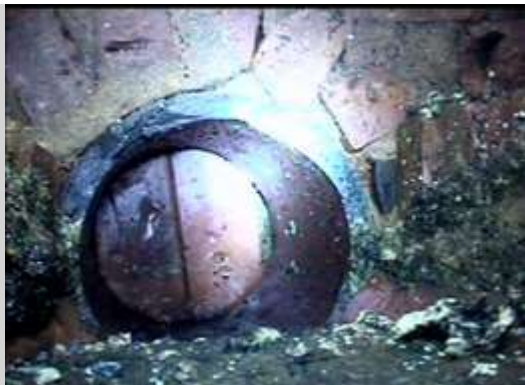
3 O'Clock Inflow

8 in. Circular Gravity Sewer
Pipe In @ 3 O'Clock

Invert Depth: **9.98** (ft.) Flow Characteristics: **None**

Deposits: ☐ None ☐ Mud ☐ Sludge ☒ **Debris** ☒ **Grease**

Silt Depth: **1** (in.) Deposits Extent: **Medium**

Connects To: **Stub connection / abandoned**

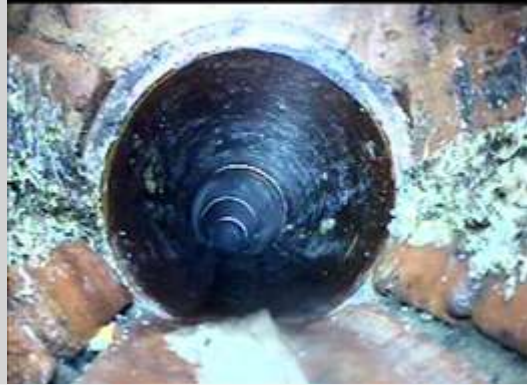
5 O'Clock Inflow

8 in. Circular Gravity Sewer
Pipe In @ 5 O'Clock

Invert Depth: **9.93** (ft.) Flow Characteristics: **Slow**

Deposits: ☐ None ☐ Mud ☐ Sludge ☐ Debris ☒ **Grease**

Silt Depth: **0.5** (in.) Deposits Extent: **Light**
